Hazardous Building Materials Assessment Nominated areas of Cox Peninsula Northern Territory

Jacobs

March 2015

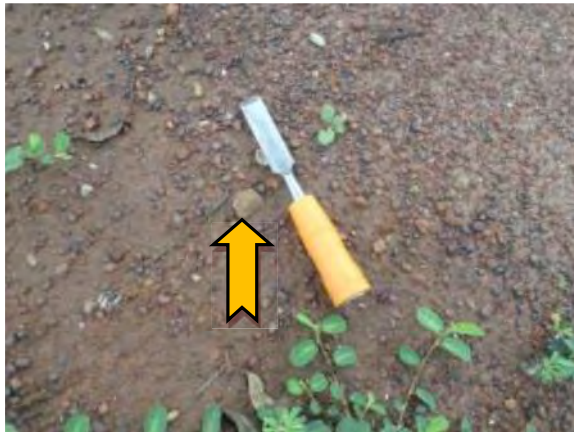
Photo 1. Section 32 – Area B, external, south-east corner, debris – **asbestos** fibre cement sheet. Sample: 17069-001-025.

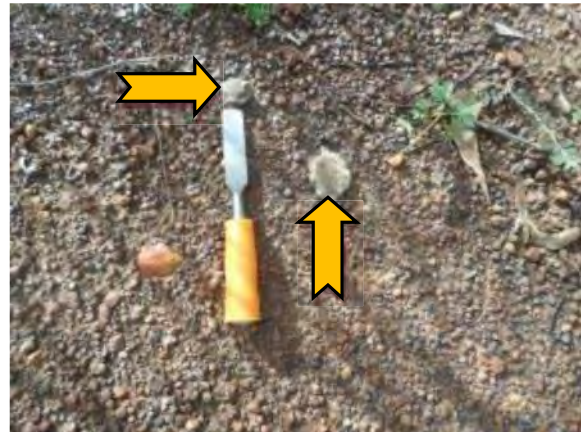
Photo 2. Section 32 – Area B, external, east area, debris – **asbestos** fibre cement sheet. Sample: 17069-001-026.

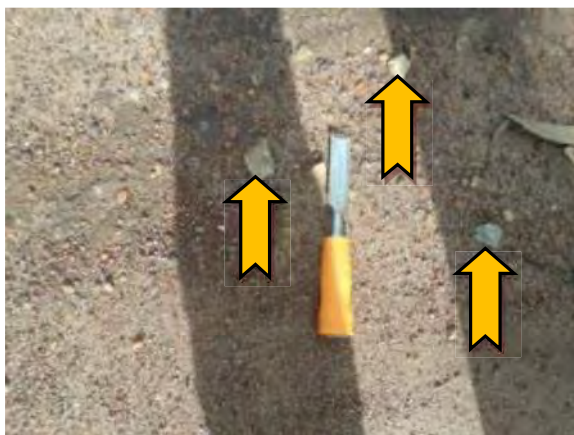
Photo 3. Section 32 – Area B, external, central area, debris – **asbestos** fibre cement sheet. Reference: 17069-001-026.

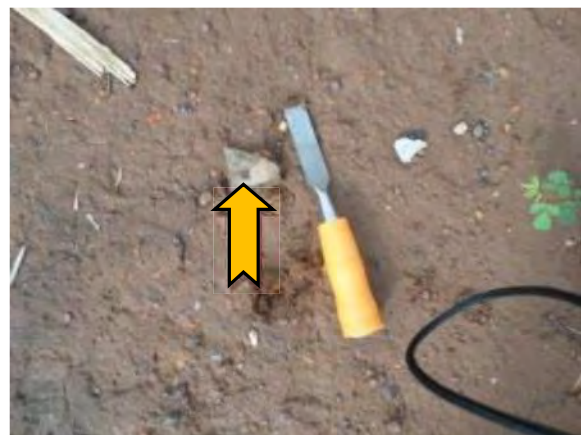
Photo 4. Section 32 – Area B, external, central area, debris – **asbestos** fibre cement sheet. Reference: 17069-001-026.

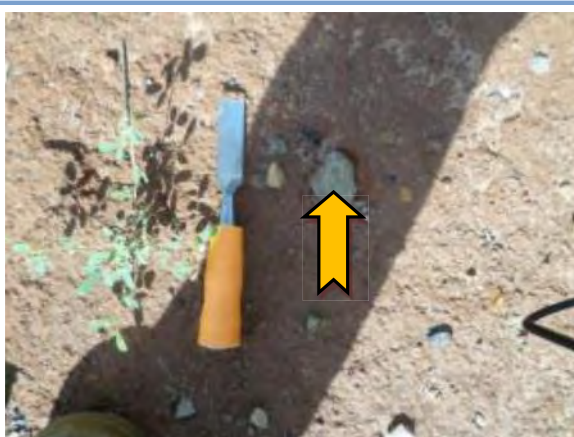
Photo 5. Section 32 – Area E1, external, south-east corner, debris – **asbestos** fibre cement sheet. Sample: 17069-001-027.

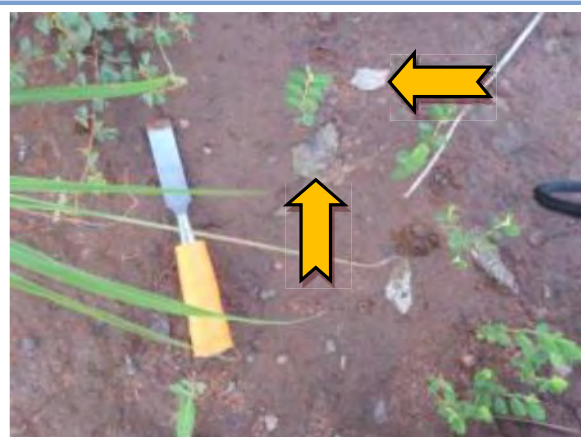
Photo 6. Section 32 – Area E1, external, north-west corner, debris – **asbestos** fibre cement sheet. Sample: 17069-001-028.

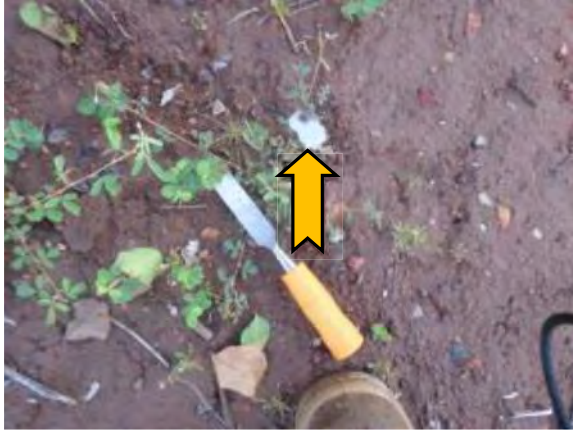
Photo 7. Section 32 – Area E1, external, north central area, debris – **asbestos** fibre cement sheet. Reference: 17069-001-028.

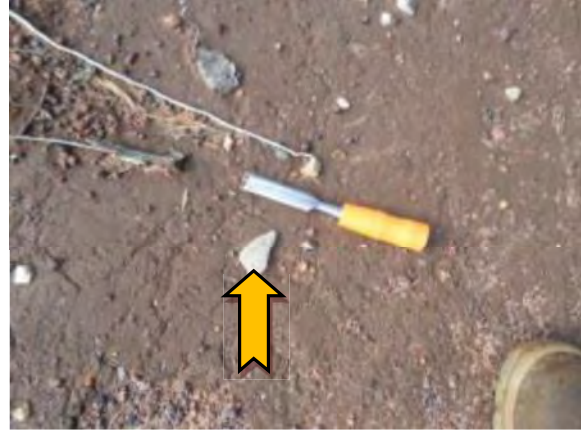
Photo 8. Section 32 – Area E1, external, west area, debris – **asbestos** fibre cement sheet. Reference: 17069-001-028.

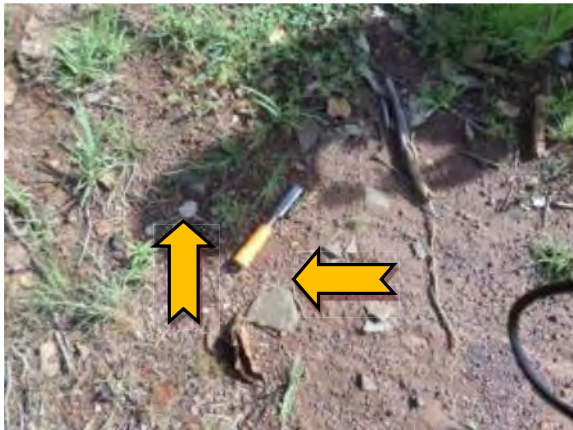
Photo 9. Section 32 – Area E1, external, east of 32 compound, debris – **asbestos** fibre cement sheet. Reference: 17069-001-028.

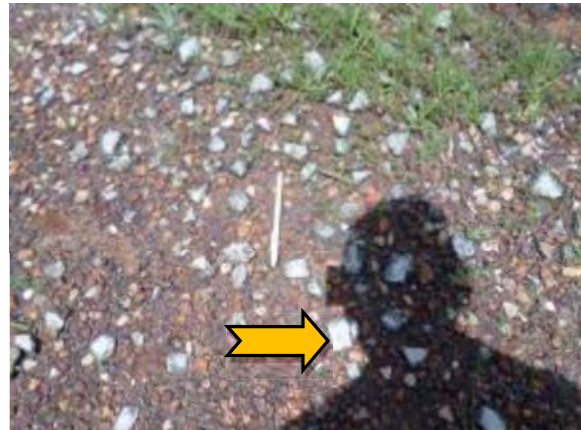
Photo 10. Section 32 – Area E1, external, north-west corner of 32 compound, debris – **asbestos** fibre cement sheet. Reference: 17069-001-028.

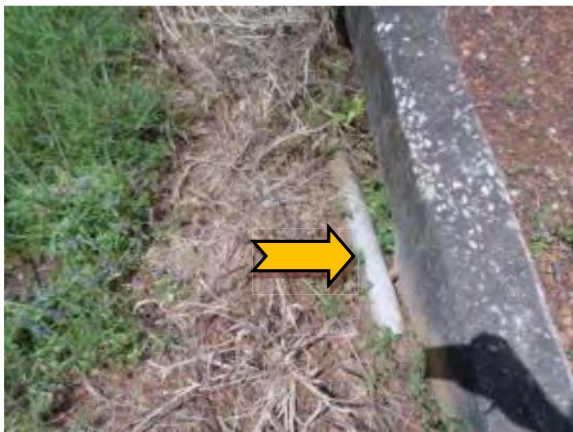
Photo 11. Section 32 – Area E1, external, east of 32 compound, pipe in drainage area – **asbestos** moulded fibre cement. Reference: 17069-001-028.

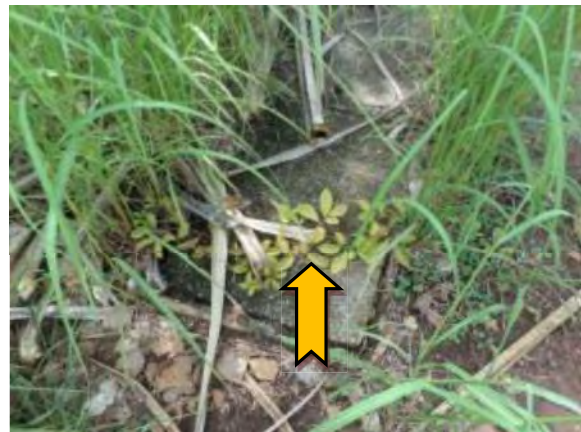
Photo 12. Section 32 – Area E1, external, various locations, service pits – **asbestos** moulded fibre cement.

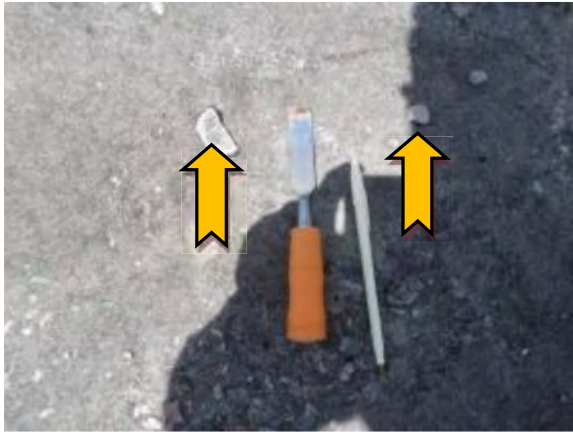
Photo 13. Section 32 – Area E1, external, inside 32 compound, debris – **asbestos** fibre cement sheet. Sample: 17069-001-029.

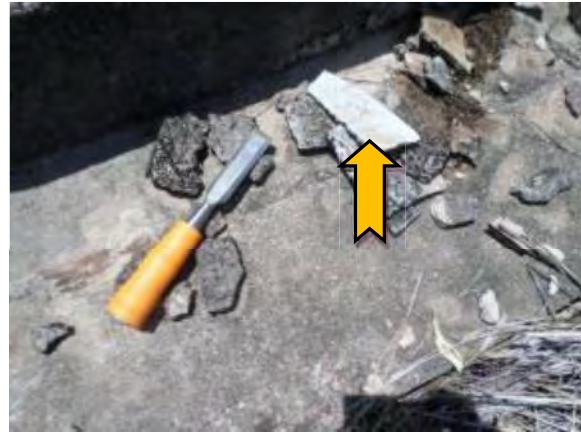
Photo 14. Section 32 – Area E1, external, inside 32 compound, debris – **asbestos** fibre cement sheet. Reference: 17069-001-029.

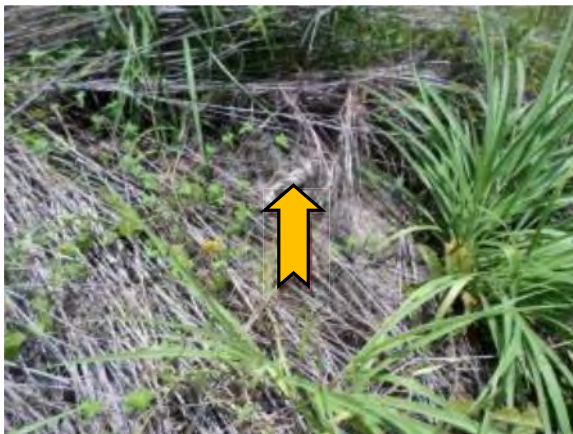
Photo 15. Section 32 – Area E1, external, inside 32 compound, debris – **asbestos** fibre cement sheet. Reference: 17069-001-029.

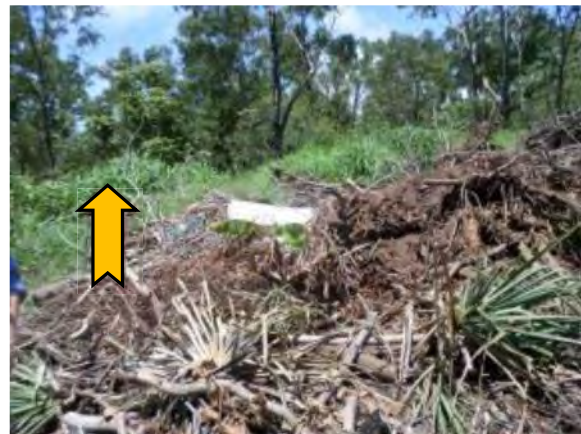
Section	Area	Findings
Section 32	Wagait Landfill (Area D)	Asbestos-containing debris is assumed to be present at the Wagait landfill site. It should be noted that this area is constantly transforming due to the transporting, burying and burning of waste. Furthermore, the cover changes from approximately November to April due to the wet season i.e. the area is overgrown with vegetation. This is particularly evident in the south-east corner of the site where it is understood that asbestos containing debris has previously been identified.
	Area B	Non-friable asbestos in the form of fibre cement sheet debris was identified on the surface of the ground throughout the site. Sample collection was conducted at representative areas at the site and the debris was observed to be extensive throughout.
	Area E1	<ul style="list-style-type: none"> Non friable asbestos fibre cement sheet and corrugated cement sheet debris was identified on the surface of the ground throughout the site. Sample collection and visual observations were conducted within the 32 compound and outside of the 32 compound perimeter fence. Debris was observed to be extensive throughout the site; and Non-friable asbestos moulded cement in the form of service pits and conduits were observed throughout the site. It should be noted that these asbestos items were not sampled at the time of the assessment at the discretion of Jacobs. It is understood that these items have previously been identified by SKM in 2013 and have documented in this report.

Photo 16. Section 32 – Wagait Landfill, external, south-east corner, debris – Assumed **asbestos** fibre cement sheet.

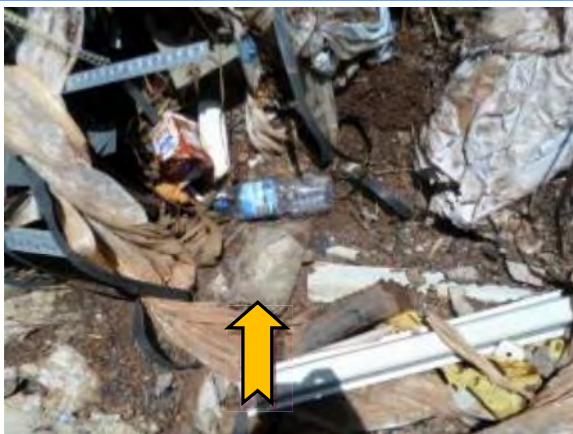
Photo 17. Section 32 – Wagait Landfill, external, north-west perimeter of landfill, debris – assumed **asbestos** fibre cement sheet.

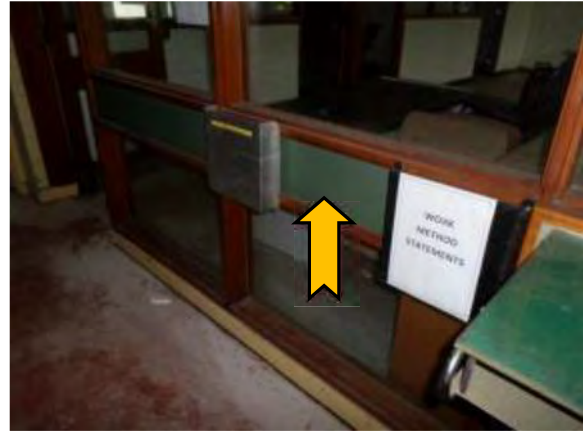
Photo 2. Section 34 – Administration Building, ground floor, room 3 (corridor), infill panels – **asbestos** fibre cement sheet. Sample: 17069-001-010.

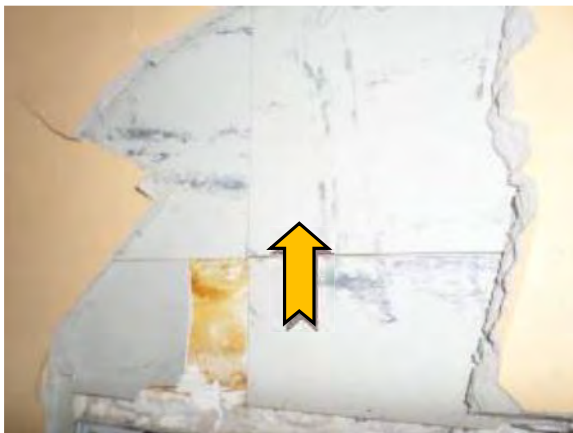
Photo 3. Section 34 – Administration Building, ground floor, room 7 (female toilet), wall lining – grey **asbestos** vinyl wall tiles. Sample: 17069-001-008.

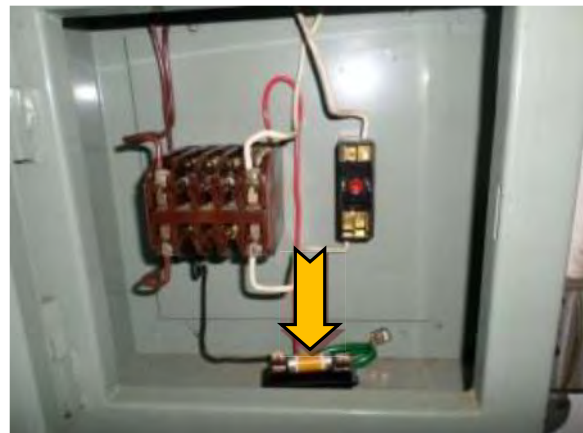
Photo 4. Section 34 – Administration Building, ground floor, room 9 (comms room switchboard), redundant fuse – **asbestos** millboard insulation. Sample: 17069-001-009 (removed as sampled).

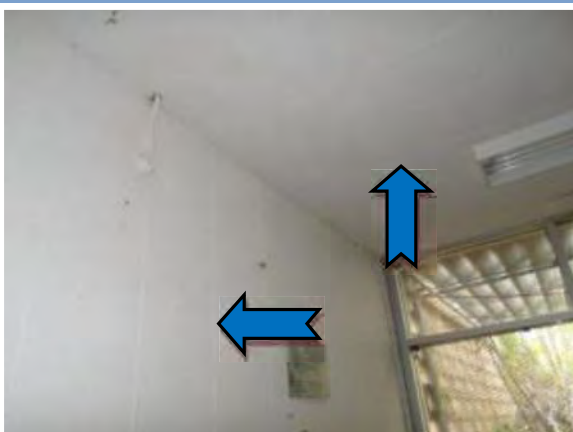
Photo 5. Section 34 – Administration Building, ground floor, room 11 (former site office), walls and ceiling space – suspected SMF insulation material.

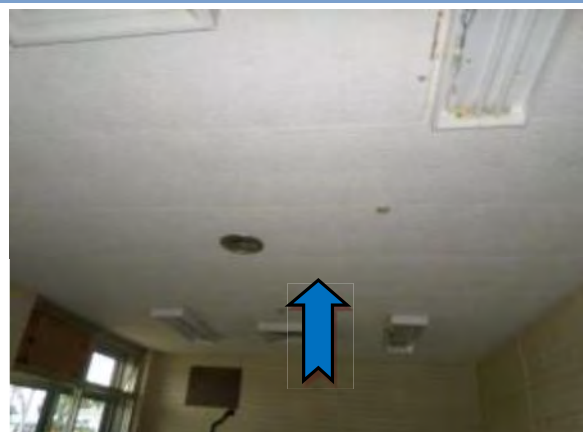
Photo 6. Section 34 – Administration Building, ground floor, room 19 (residents hall, kitchen), ceiling – suspected SMF ceiling tiles.
