DHA Stockton Rifle Range Stockton Beach Coastal Engineering Assessment

December 2016

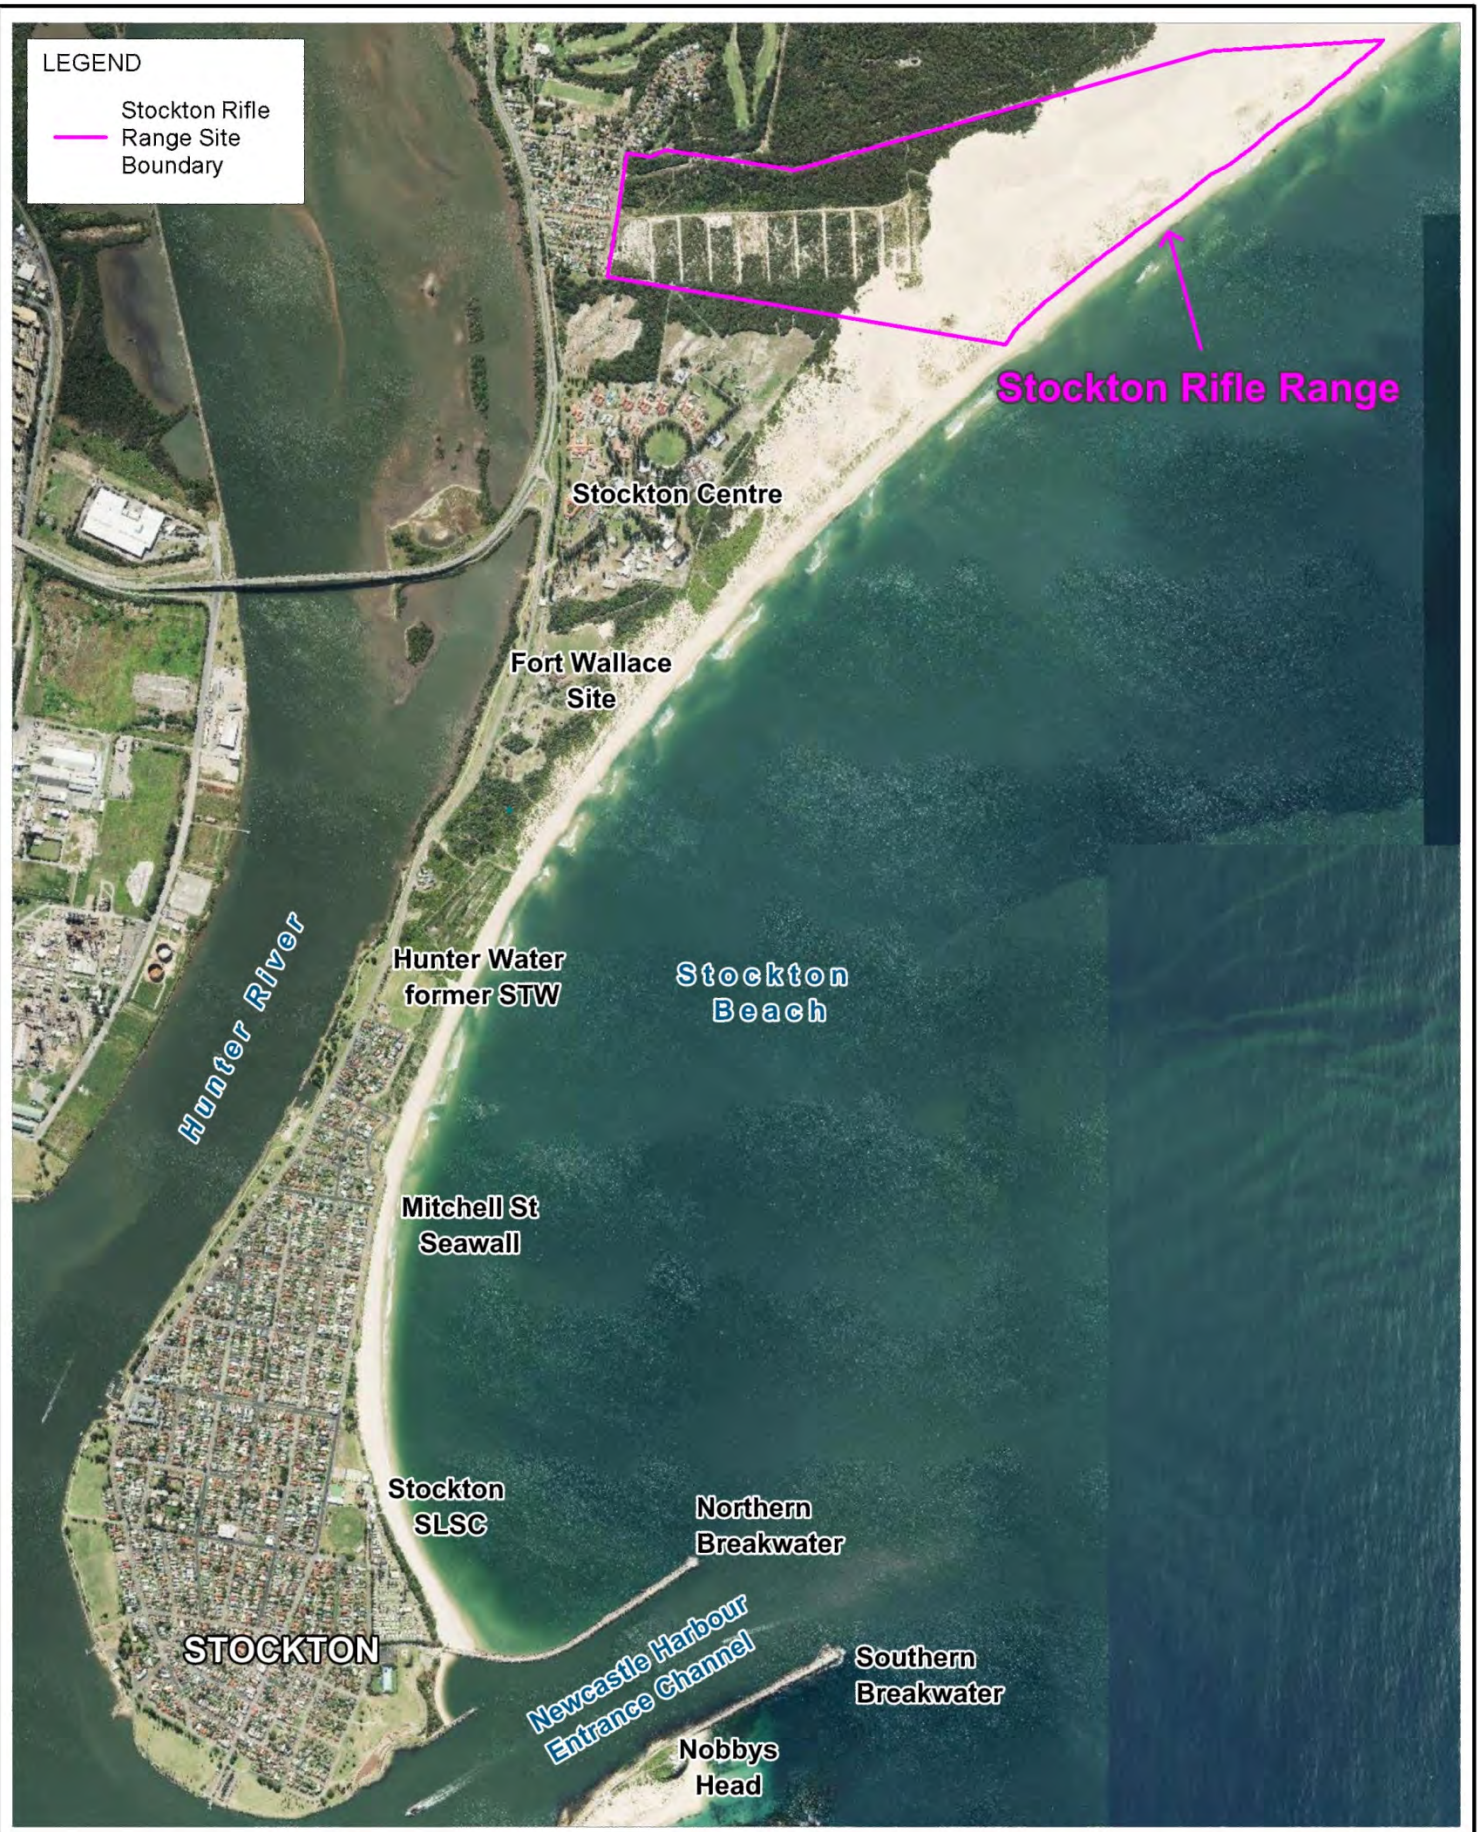
Figure:
1-1

The Stockton Rifle Range site lies on Stockton Beach in NSW around 5.2 km north of Newcastle Harbour entrance, as shown in Figure 1-1. The site lies north of the existing residential development at Stockton, and adjacent to the Stockton Centre. The entire site extends to the shoreline of Stockton Beach, however the proposed development footprint will not extend onto the foredunes or beach.

Title:
Locality Plan for Stockton Rifle Range

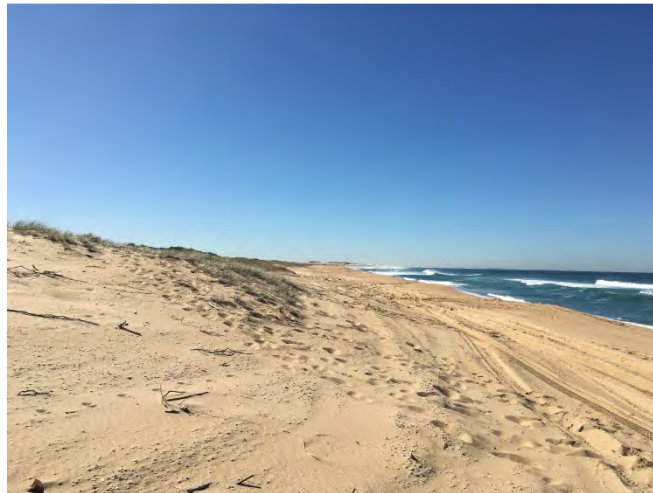
The beach does not currently exhibit signs of erosion even after the recent June 2016 storms (see Figure 2-1). The June 2016 event arrived from a more north easterly direction, and so caused

Figure 2-1 Beach appears accreted, historical recession not presently evident

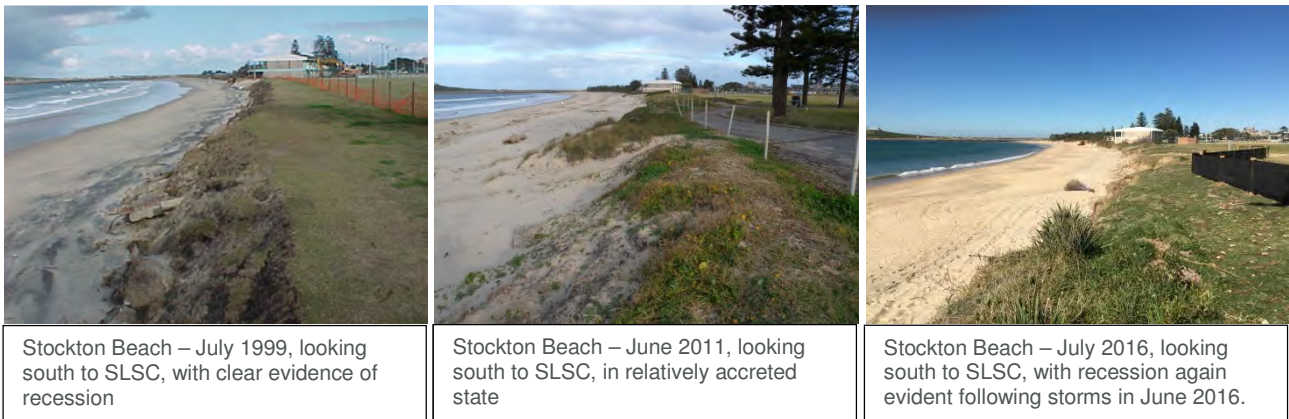
Recession has previously threatened development in the central section of the beach along Mitchell Street as well as facilities such as the Stockton Beach Surf Life Saving Club (SLSC) house and pavilion, at the southern end of the beach (see Figure 2-2). Four treatment ponds were constructed in the late 1960's on HWC's Wastewater Treatment Works (adjacent to Fort Wallace). One pond has been lost to erosion and the next most seaward pond is now under threat.

Figure 2-2 Stockton Beach Key Area of Recession over time

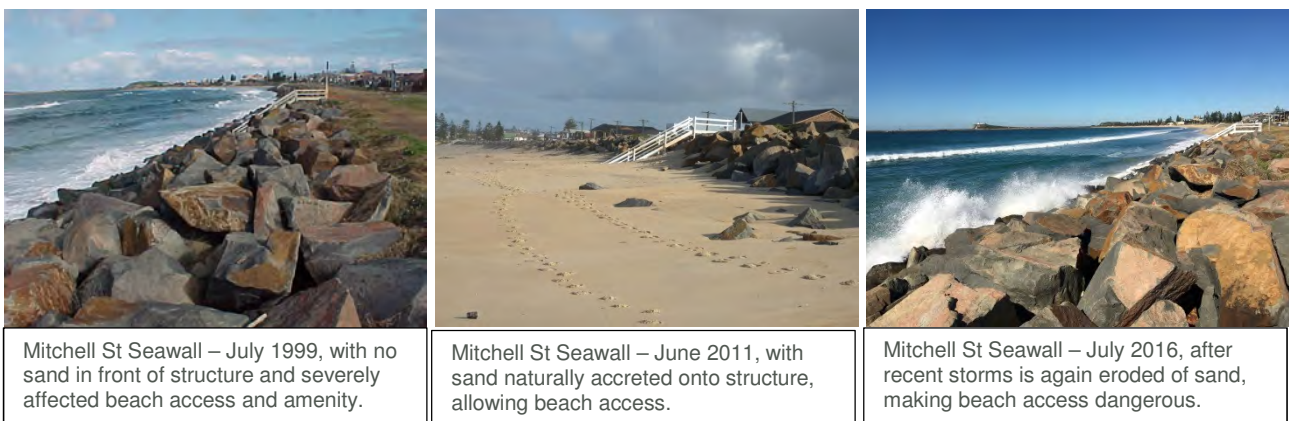
In 1989 in response to the erosion threat, a substantial rock seawall was constructed between Pembroke Street and Stone Street to protect the adjacent section of Mitchell Street and residential properties (see Figure 2-3). A sandbag wall with a design life of 5 years was also constructed in November 1996 to provide interim protection for the Stockton SLSC. The sandbag wall was implemented as a short term solution, however, it is still present and functional some 20 years later today. In June 2011, the sandbag wall was extended at the base of the SLSC towards the north. The sandbag structure was recently exposed during storms in June 2016.

Figure 2-3 Stockton Beach Mitchell St Seawall and Recession over time

A dune system was formed between the northern breakwater and Pembroke Street, and north of the rock seawall to Meredith Street during the period 1988 to 1991. Severe erosion in the mid-1990s effectively removed these dune reconstruction works. In the late 1990s, a new dune system was constructed south from the SLSC and seaward of the Stockton Caravan Park. Between the SLSC and Mitchell St seawall, a dune system is absent and the general ground level is as low as 4.0m AHD in places (see Figure 2-2). This area was further eroded during the June 2016 storms.

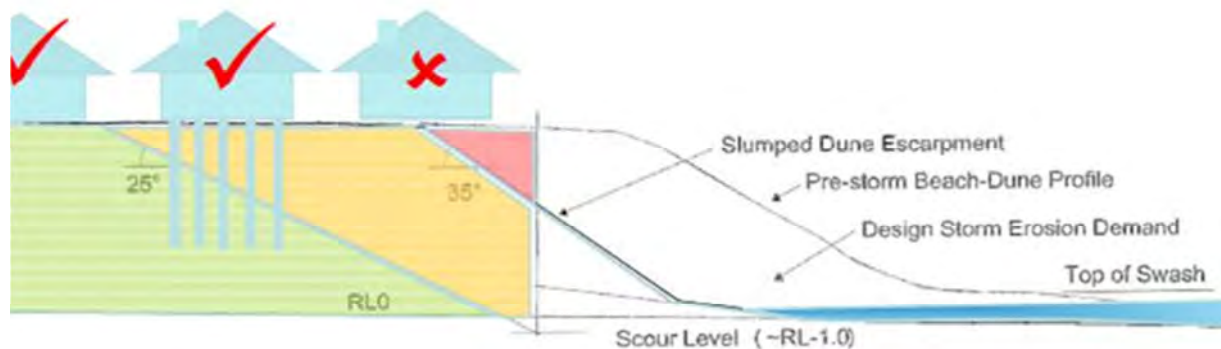
As shown in Figure 3-3, these zones are shaped as a wedge, and so, stable foundation can be reached below the zones. Developments in the immediate vicinity of beaches with the potential to be affected by the zone of reduced foundation capacity may require foundation piles that penetrate to the stable foundation zone (see Figure 3-4).

Figure 3-4 Using Foundation Piles to access the Stable Foundation Zone
