# Survey of Carter's Freshwater Mussel in the Lower Vasse River to inform future sediment removal

June 2021

Prepared for:  
City of Busselton

Prepared by:  
Centre for Sustainable Aquatic Ecosystems  
Harry Butler Institute, Murdoch University  
& Ottelia Ecology

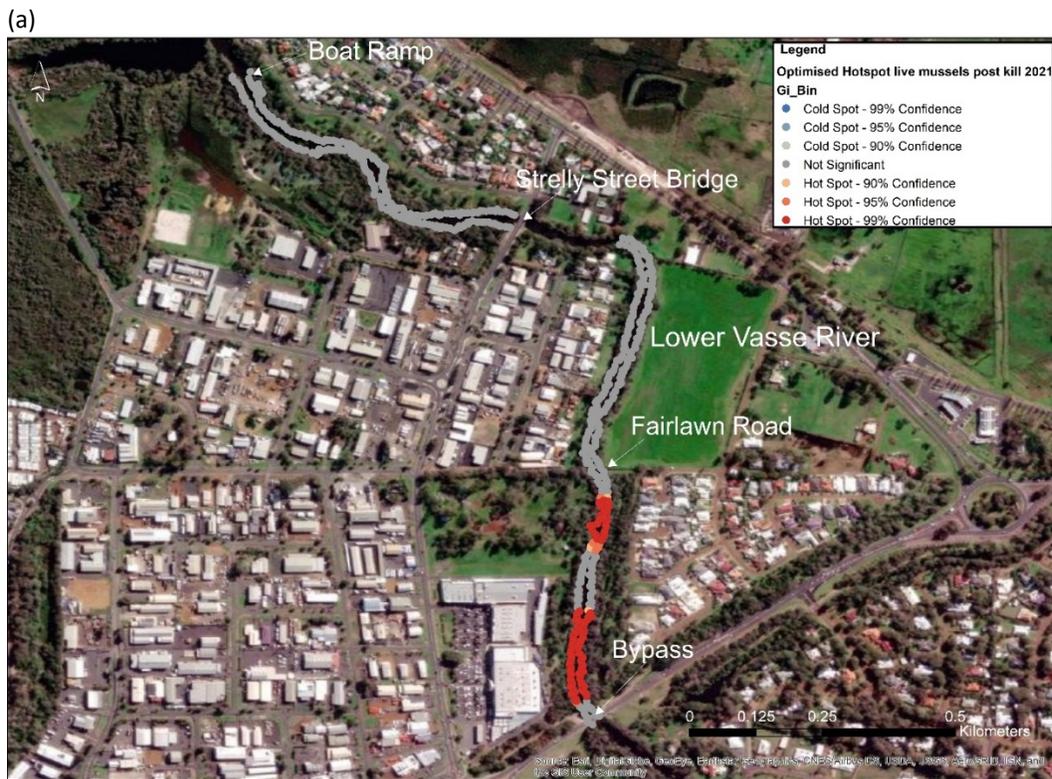
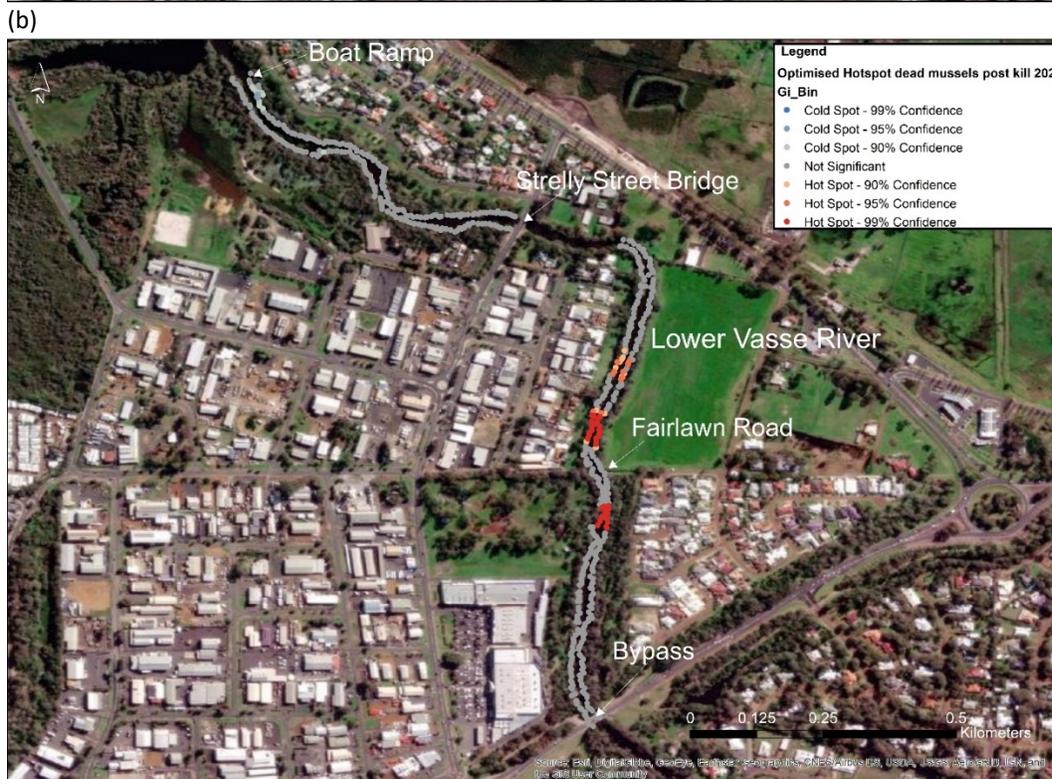
Figure 3. Optimised Hotspot analysis showing significant hotspots of live (a) and dead (b) *W. carteri* in Stage 2 survey areas from the boat ramp to the Busselton Bypass.

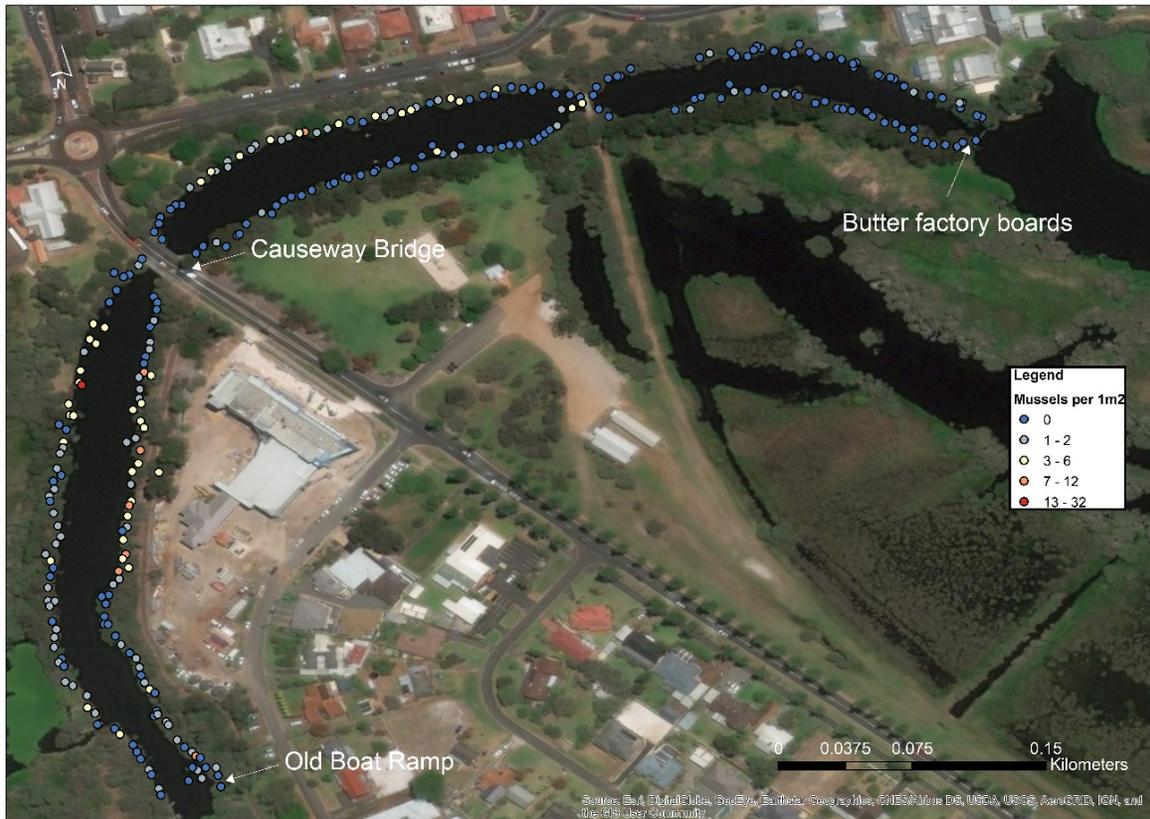
Location of the 1-m<sup>2</sup> quadrats surveyed for *W. carteri* in the survey area downstream of the boat ramp and live mussel density found in December 2020. These mussels are likely to have since died due to saltwater incursion.

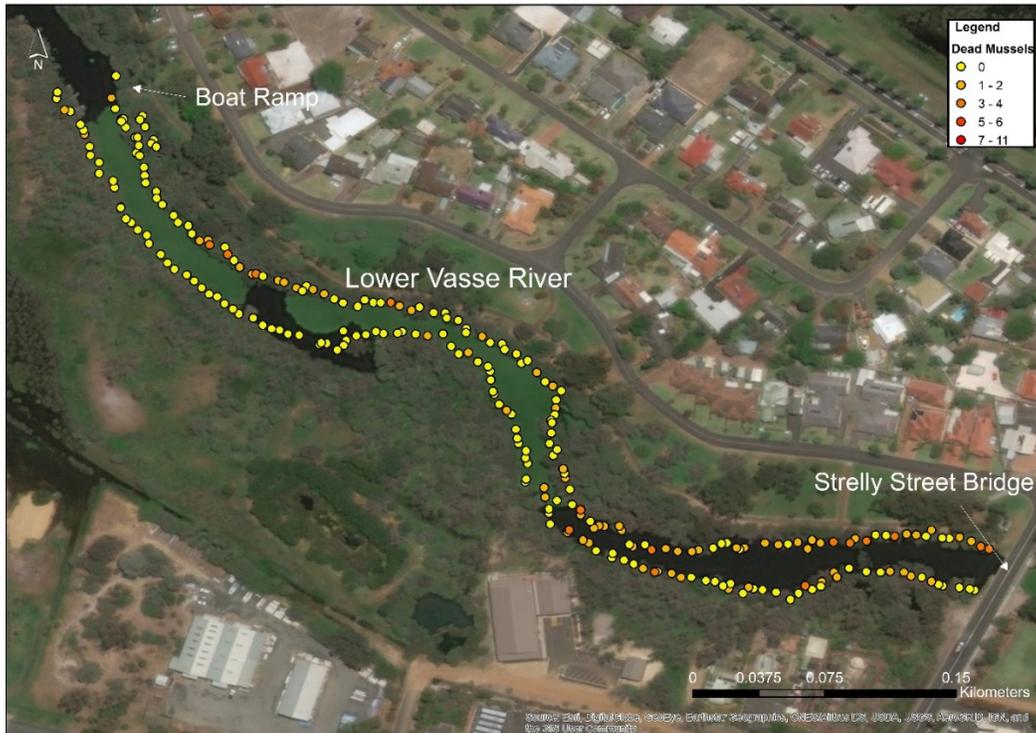
Location of the 1-m<sup>2</sup> quadrats surveyed for *W. carteri* in the survey area from the boat ramp to Strelly St and density of dead mussels found in April-May 2021.

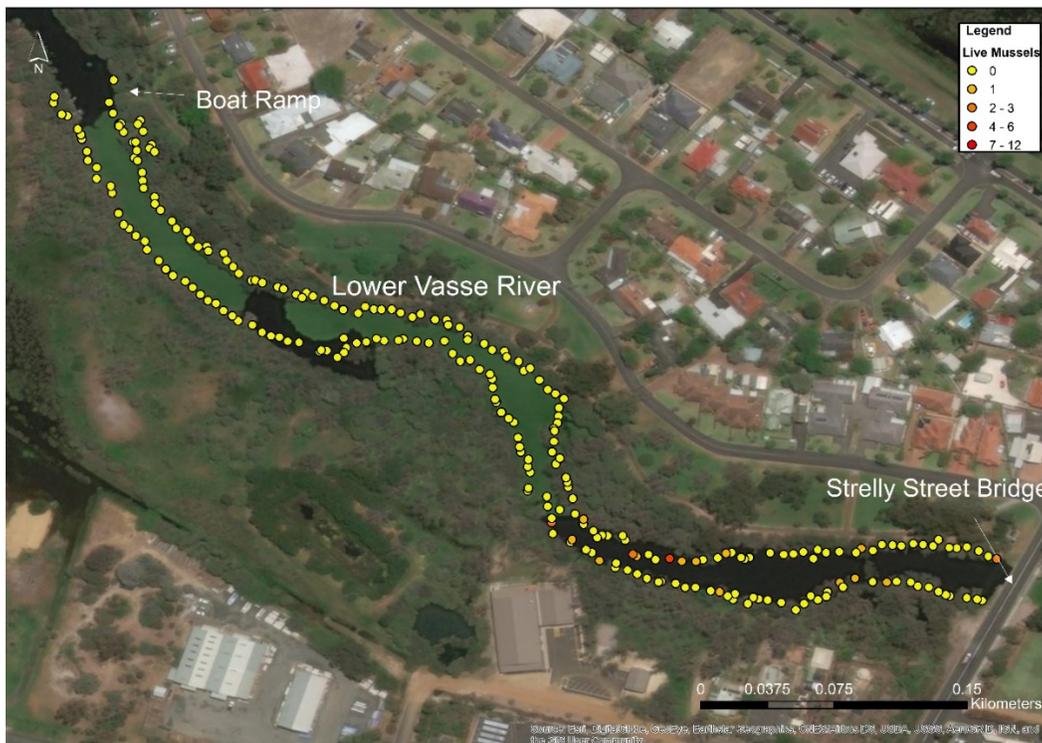
Location of the 1-m<sup>2</sup> quadrats surveyed for *W. carteri* in the survey area from the boat ramp to Strelly St and density of live mussels found in April-May 2021.

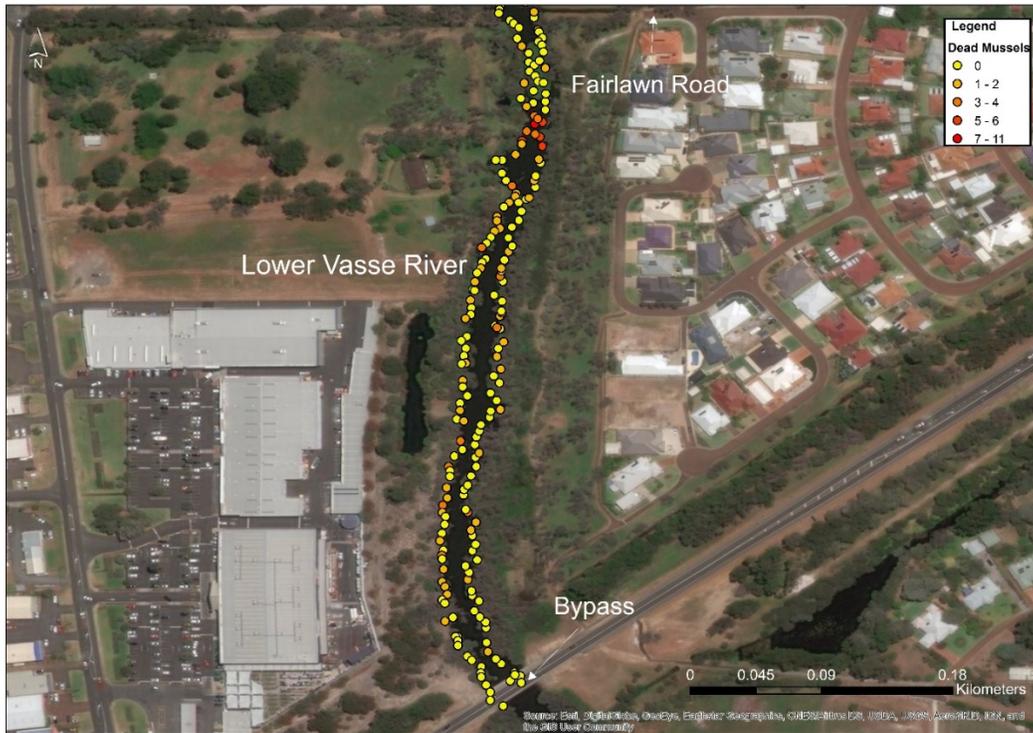
Location of the 1-m<sup>2</sup> quadrats surveyed for *W. carteri* in the survey area from Fairlawn Rd to Busselton Bypass and density of dead mussels found in April-May 2021.
