Preliminary Site Investigation

BRUCE HALL PRECINCT,
ACTON

NOVEMBER 2016

Project no: 2270135A
Date: November 2016

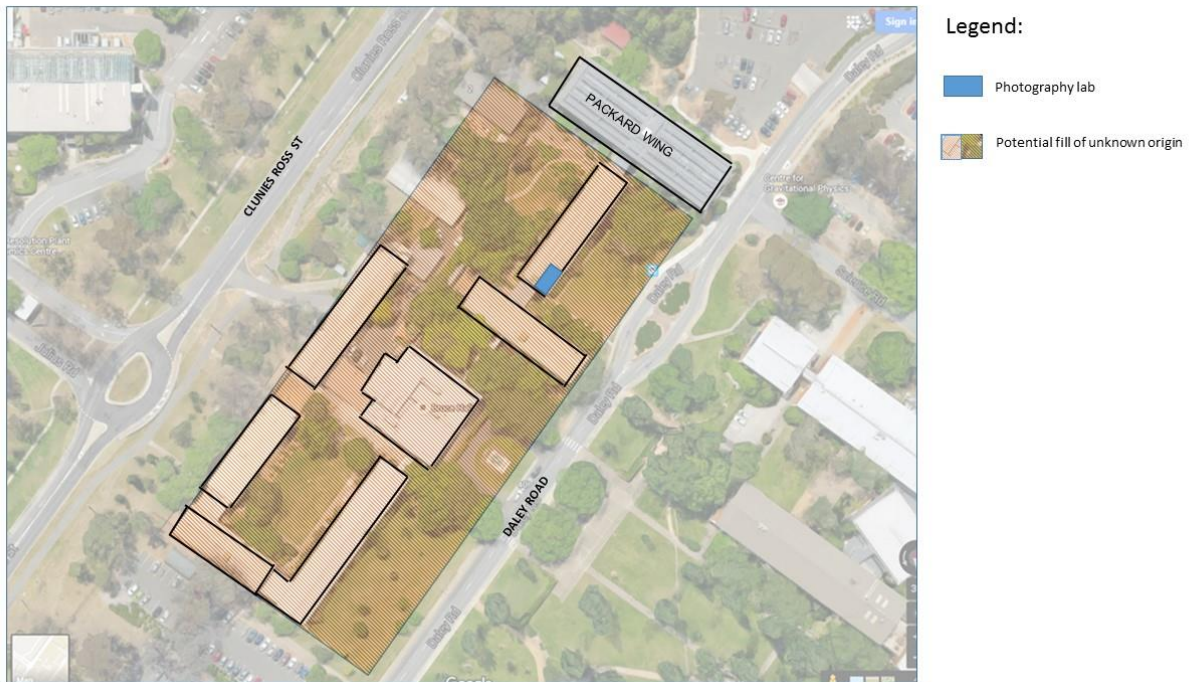
Figure 4.1 AECs on site

AEC	POTENTIALLY CONTAMINATING ACTIVITY	LIKELIHOOD OF CONTAMINATION	COPC
AEC 02	Fill material of unknown origin	Moderate	General environmental suite including, general builders rubble, heavy metals, petroleum hydrocarbons, pesticides, PAHs, and asbestos containing materials
AEC 01	Historic storage and disposal of photographic chemicals	Moderate	Heavy metals and metalloids such as silver and boron, acids
AEC 03 (unknown locations)	USTs associated with fuel storage for heating	Moderate	Petroleum Hydrocarbons

The AECs are illustrated on Figure 5.1.

- The potential for contamination to be present on the site as a result of past and present land use activities is considered to be moderate.
- WSP | PB has identified three areas of environmental concern, however, more data is required to adequately assess the risks associated with these. Further investigations and a targeted Phase 2 investigation is recommended after demolition occurs.
