SEDIMENT SAMPLING AND ANALYSIS PLAN IMPLEMENTATION REPORT

Eden Breakwater Wharf Extension

Prepared for: Department of Primary Industries - Lands

Date: 1 October 2015

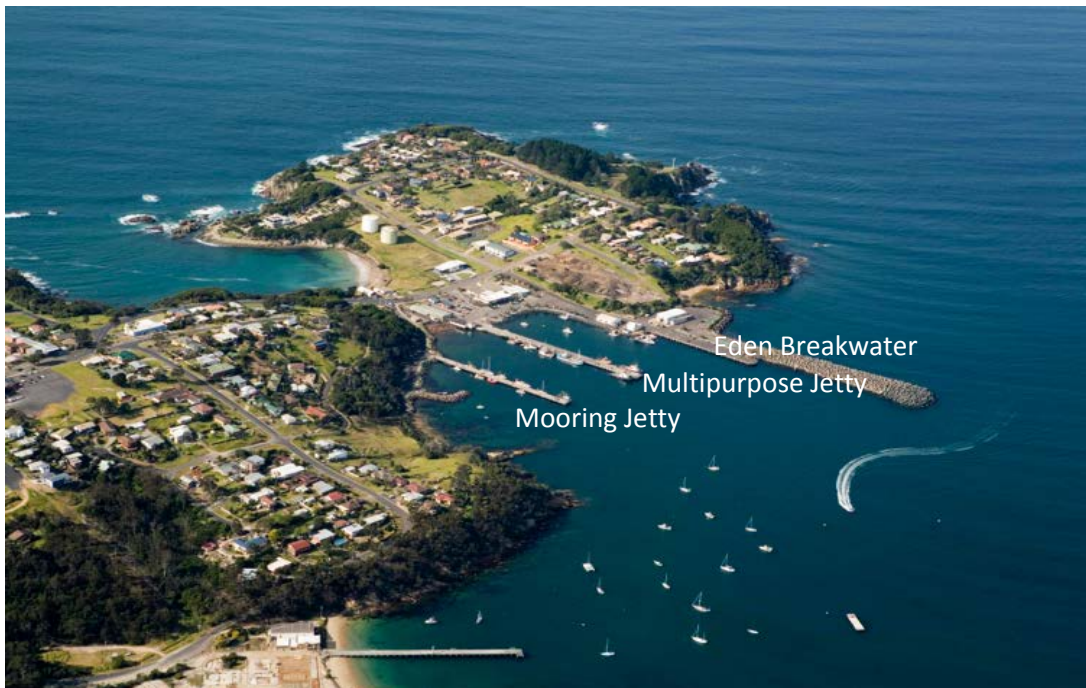
Figure 1 The location of the Breakwater Wharf in Snug Cove, Eden (referenced from Department of Primary Industries - Lands, 2014).

The Eden Breakwater Wharf is located in Snug Cove, Eden. The first wharf built for shipping was in 1860. Snug Cove consists of three wharfs, namely the Mooring Jetty, Multi-Purpose Jetty and Breakwater Wharf (see **Figure 1**). The first stage of construction of the Breakwater Wharf was in the late 1970's, with construction completed in 1978. The second stage of the Breakwater Wharf was then completed in the late 1980's.

The current bathymetry north of the Breakwater Wharf is between -4 m to -10 m Australian Height Datum (AHD) (GBG Australia, 2014). To ensure the safe navigation of cruise ships into the Eden Breakwater Wharf, capital dredging is proposed along the northern edge of the Breakwater.
