7 Area of inundation vegetation ground truthing assessment

7.1 Context

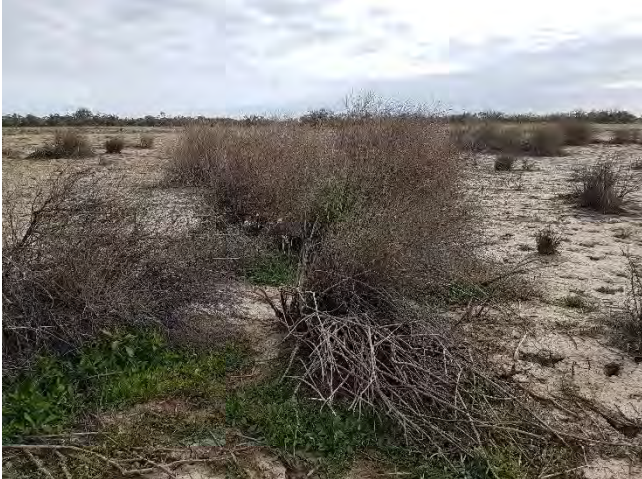
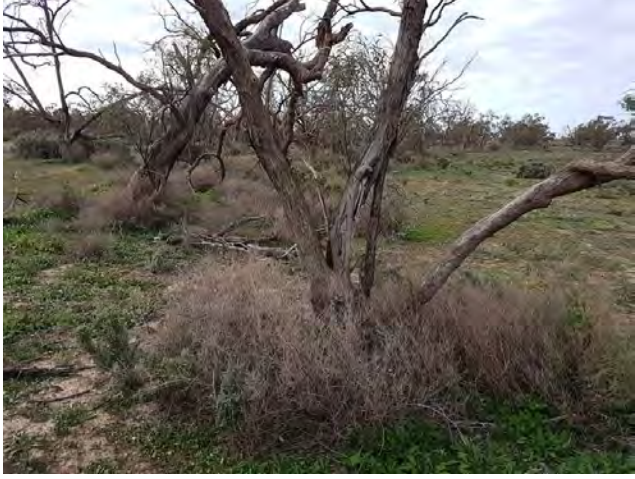
<p>Plate 1 – Patch of vegetation identified by DELWP modelled mapping as containing EVC 98 – Semi-arid Chenopod Woodland. The vegetation at this location consisted of Lignum Shrubland (EVC 808) dominated by <i>Duma florulenta</i> (Tangled Lignum).</p>	<p>Plate 2 – Patch of vegetation containing no modelled EVC data (DELWP 2005). The vegetation at this location consisted of Riverine Chenopod Woodland (EVC 103) dominated by <i>Eucalyptus largiflorens</i> (Black Box).</p>
