Pinjarra Williams Road SLK 24-40

Phytophthora Dieback occurrence assessment – Version 0.3

Date: 05.05.2017

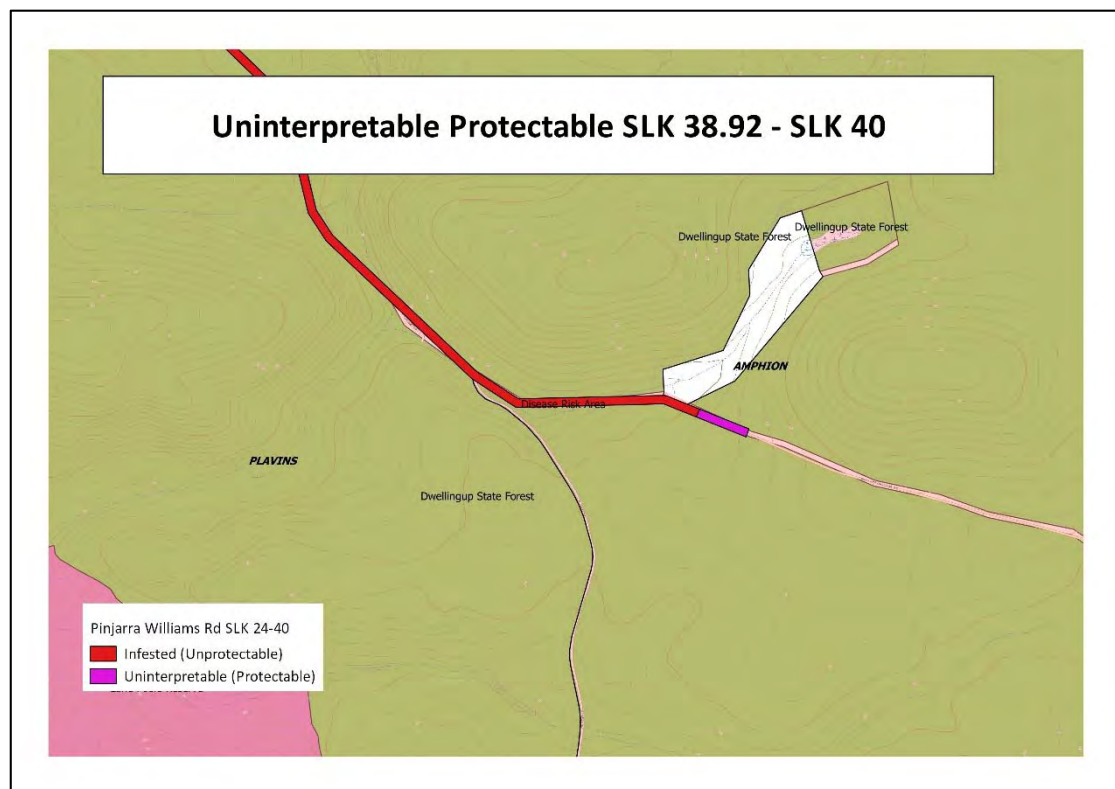
Figure 1 - Uninterpretable SLK 38.92-SLK40

The eastern end of the assessed section (Figure 1) in between 39.82 SLK and 40.00 classified as Protectable Uninterpretable and has been demarcated with pink and black striped tape. The Uninterpretable section extends beyond the bounds of this assessment and creates a larger Protectable area.

From a dieback management perspective, the site is classified as Unprotectable (Infested or Excluded) between 24.00 and 39.82 SLK and Protectable (Uninterpretable) between 39.82 and 40.00 SLK. The Protectable section occurs on both sides of the road.
