# Referral of proposed action

Boondooma Dam Spillway Repair Project

The proposed action is the repair of damage caused to the existing Boondooma Dam spillway by the 2010/11 and 2013 flood events.

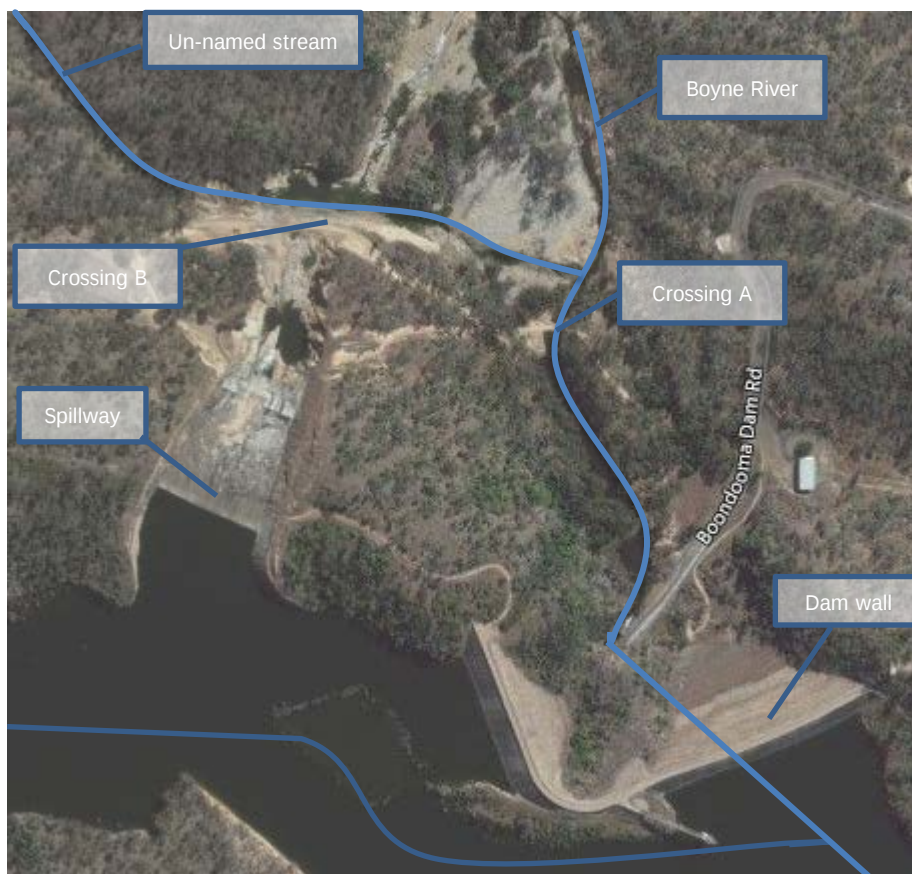
**Photo 2: Construction site overview**

The purpose of the proposed action is to strengthen the existing spillway chute to retard the rate that scour will progress in future flood events. The design features a number of defensive mechanisms which are aimed at known weakness within the natural rock in the existing spillway chute. The existing spillway is part of the dam and as such the original dam construction footprint. Previous maintenance projects have also been carried out at this site in recent years. The spillway site consists largely of excavated volcanic rock and reinforced concrete, and is not a natural watercourse (as shown in the photo below). The dam wall is located on the Boyne River and is not part of the proposed works. The spillway is located to the left of the dam wall (facing downstream) and has been cut out natural rock hill at the time of dam construction. The spillway is located in between two natural tributaries that join the Boyne River above and below dam wall.

The area encompassing the proposed action is shown in red (labelled works area) in Drawing 246180 (Appendix A), this area is referred to as the project area.

\*shown on Photo 2

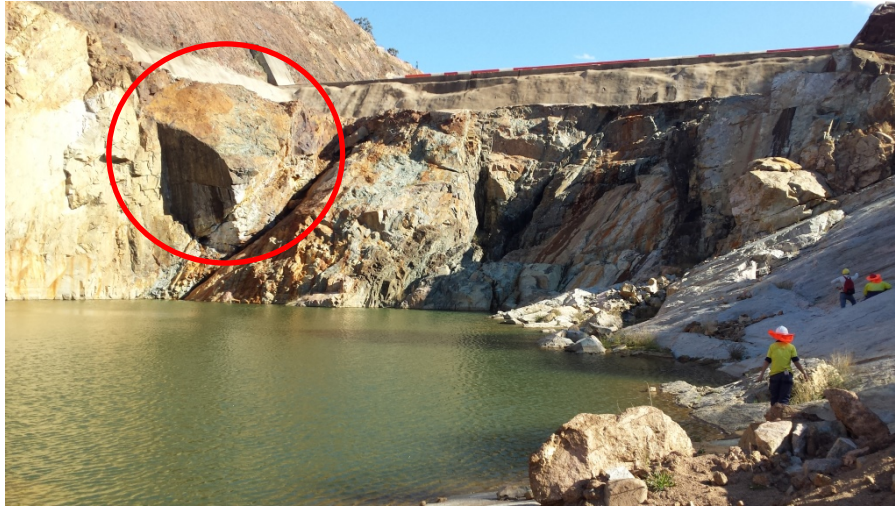
**Photo 3: Lower Spillway Chute, wedge highlighted**

Investigations have shown that the area at the right (facing downstream), upstream corner of the plunge pool, immediately adjacent to and downstream of the ECS, is the most critical section of the spillway. Due to the geometry of the chute in this area, the jet flows are stronger and more concentrated which has led to a large scour hole forming at this location.

Based on the available knowledge, this area of the spillway is a critical point and must be secured to avoid a damaging chain reaction of scour which would eventually threaten the spillway structure. Therefore, slope stability of the right wall (in the vicinity of the wedge) is a critical part of the design. The design includes a re-profiling of the slope of the right wall (near the wedge) to slopes with safe angles and benches. This will be done by pre-splitting from the top. The aim is to reduce the near vertical angle to a more stable one. Benches would separate each stage of excavation by nearly 15 m. Each bench would be used to pre-split material further down and the rock excavated material would fall into the plunge area.
