Rehabilitation Management **Cherrabah Granite Mine February 2017**

Introduction

This Rehabilitation Management Plan addresses the work required to remediate mine workings on Lot 1000 SP268215. The plan has been prepared on the following basis:

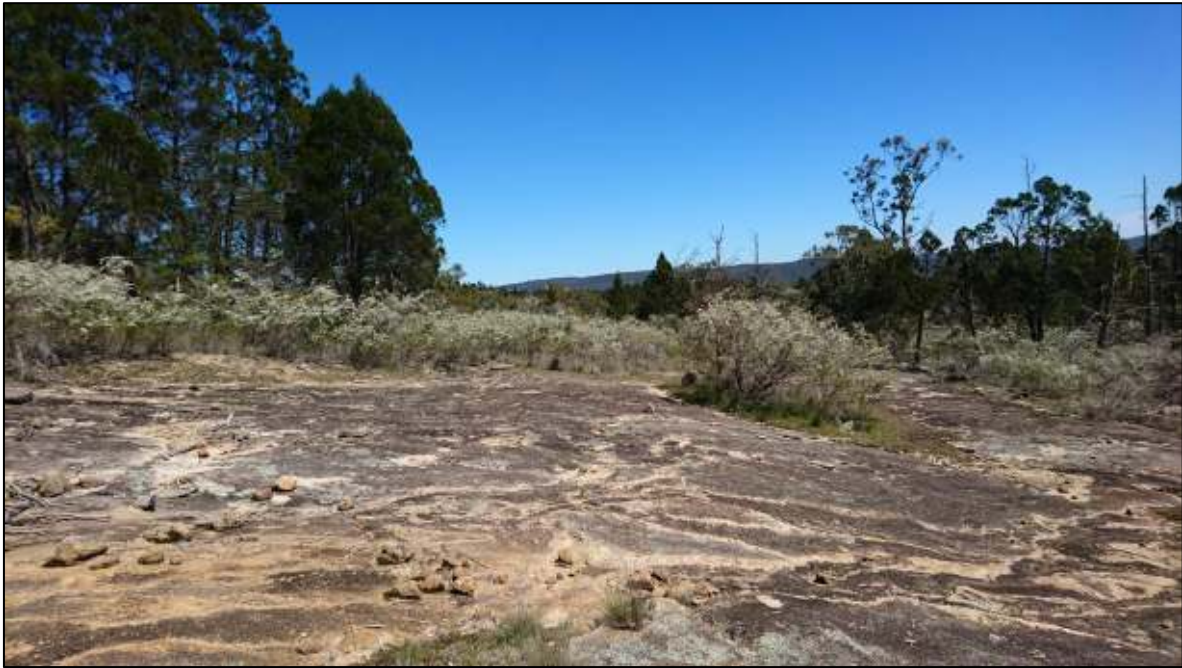
Figure 1 - View of the top of the Extraction Area showing how the vegetation within the Extraction Area forms in the crevices of the outcrop

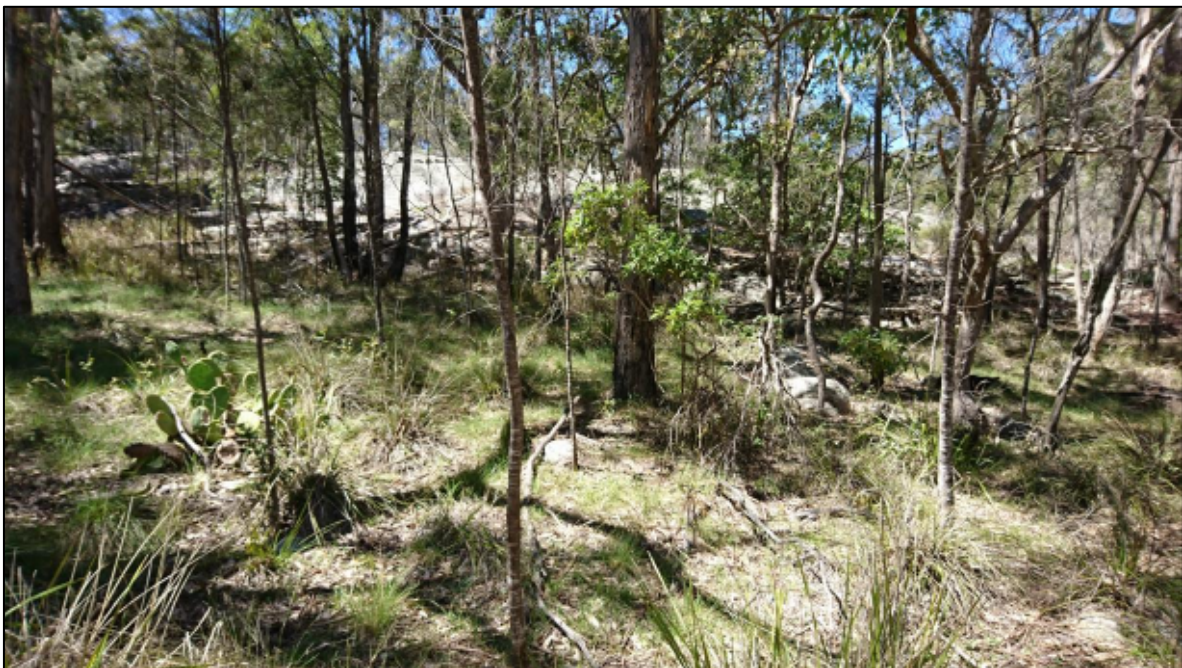
Figure 2 - View from the stockpile area showing typical vegetation communities adjacent to the Extraction Area outcrop

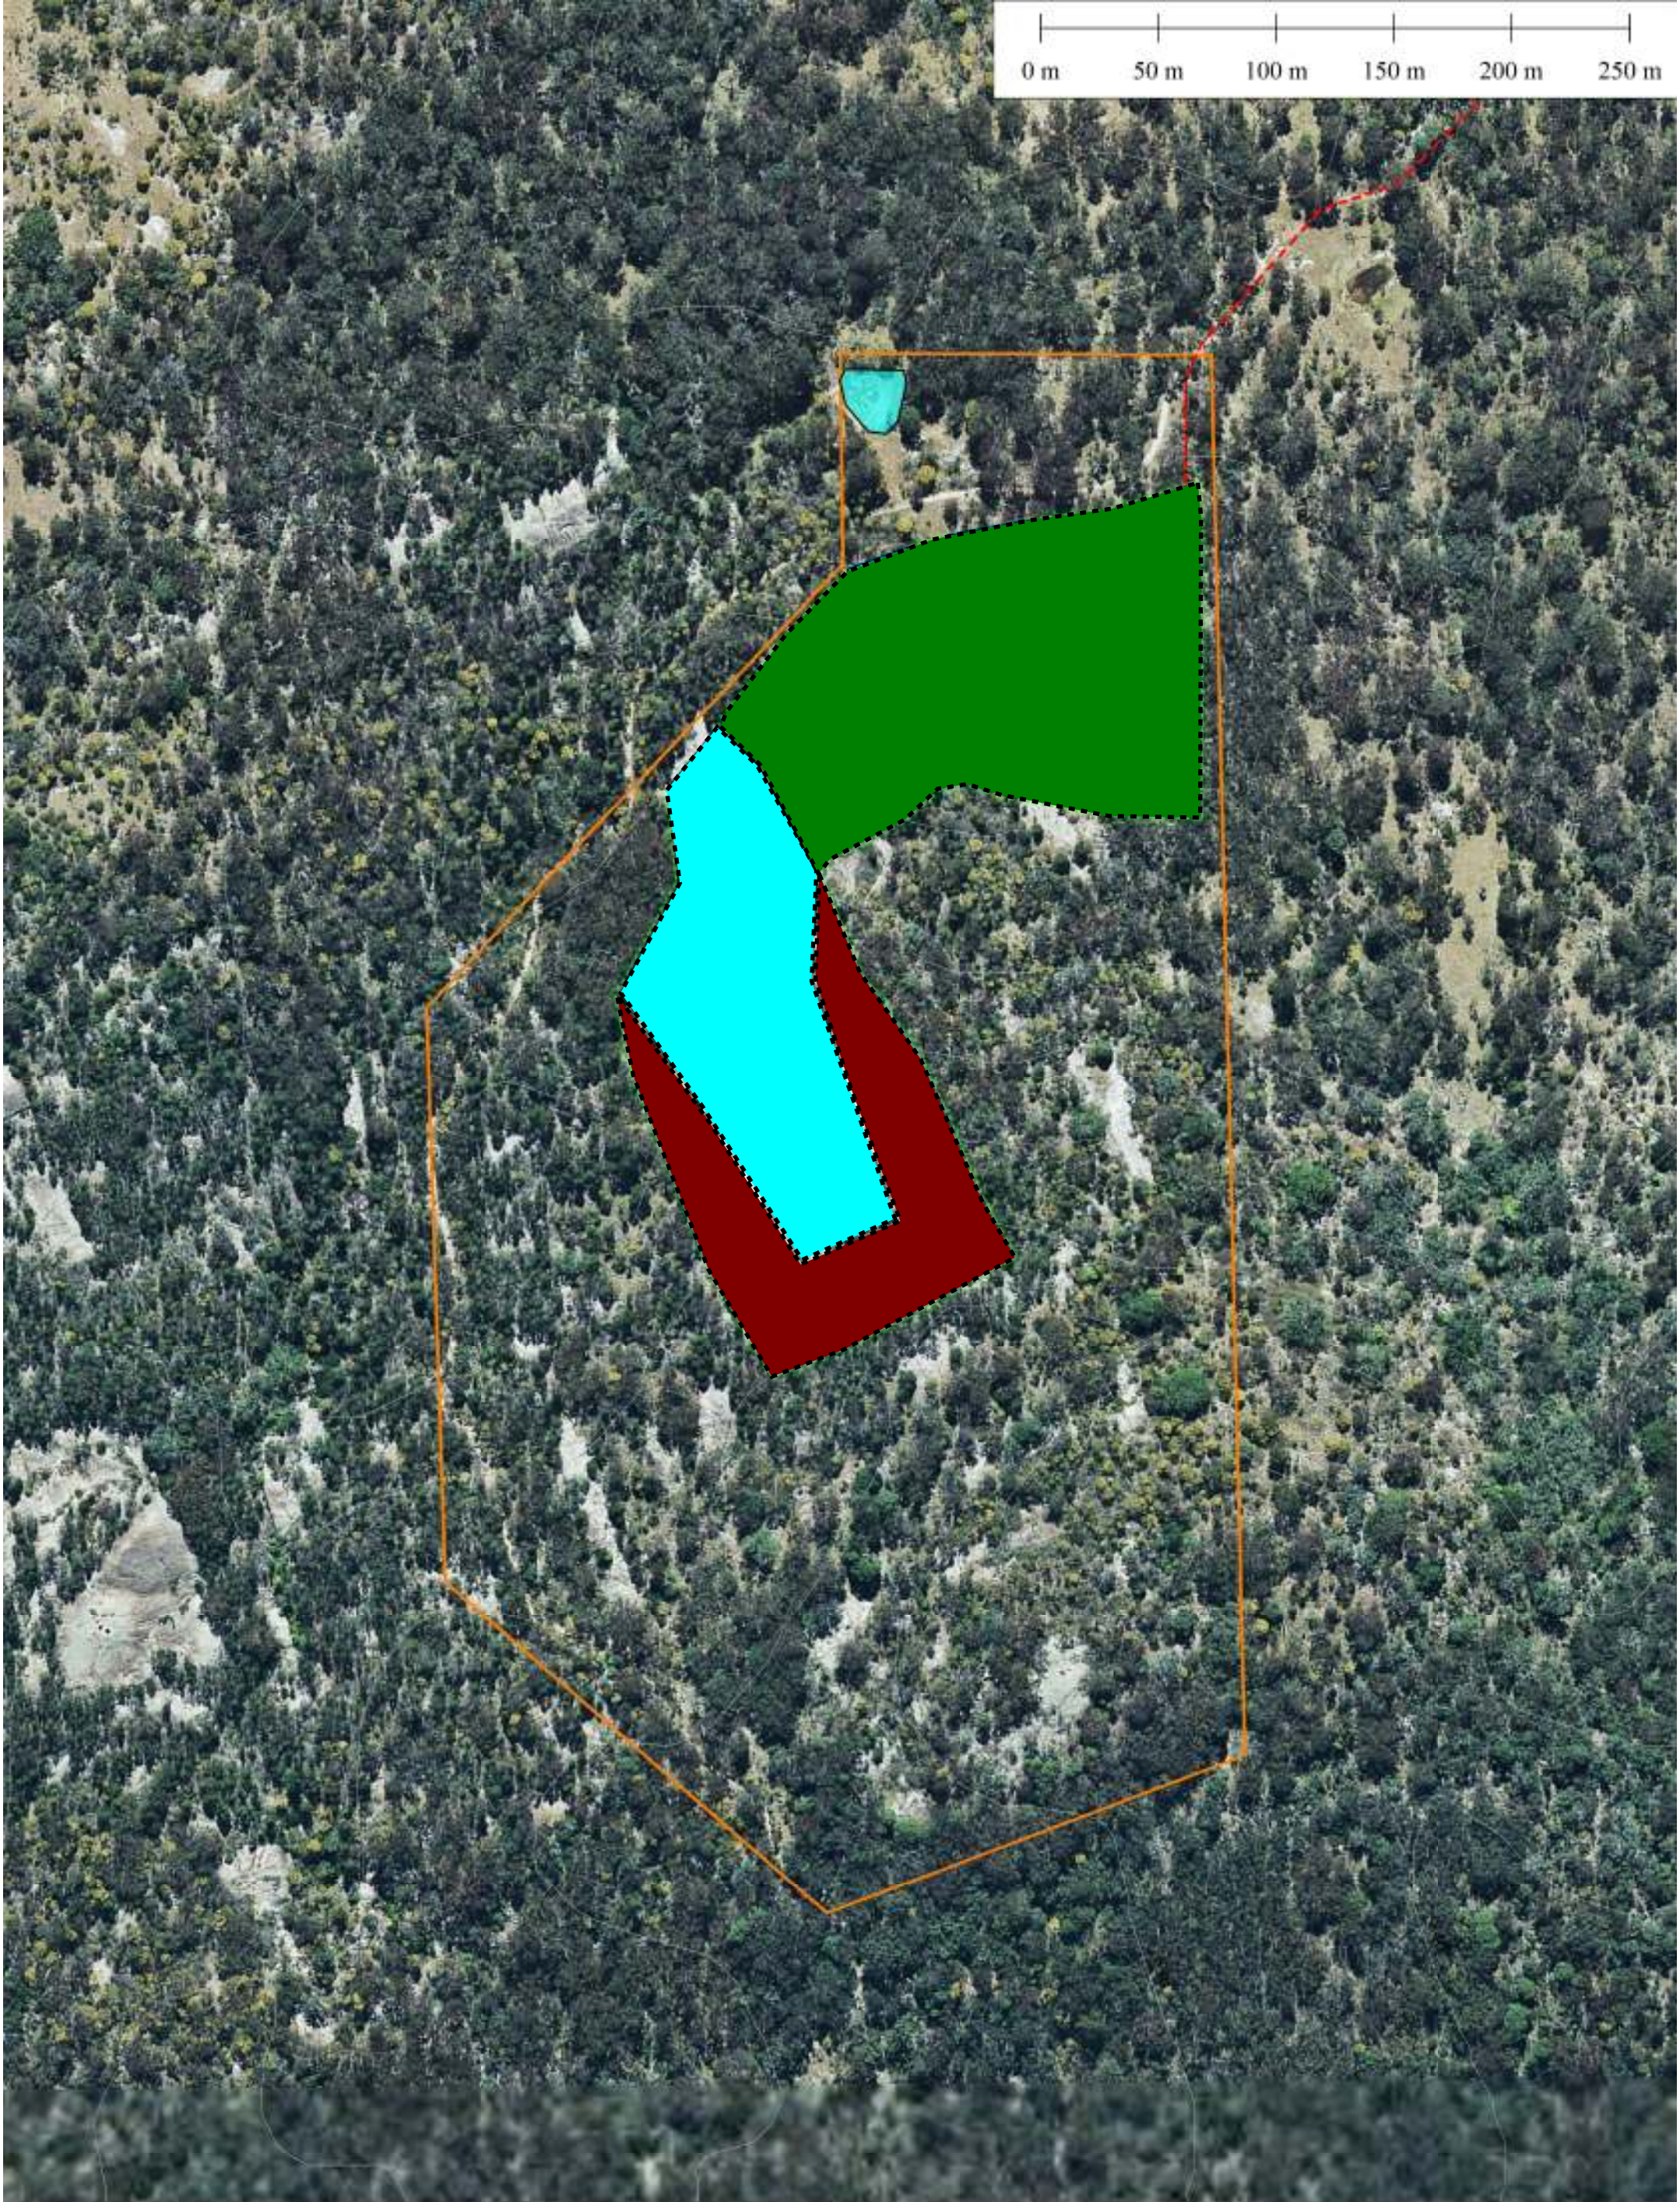
Rehabilitation Plan_V1.1 attached details the rehabilitation required in each area of the mine.
